Manhole Inspection Summary

Manhole # S45E__011MH

Insp Date: **8/14/08 10:07 AM**

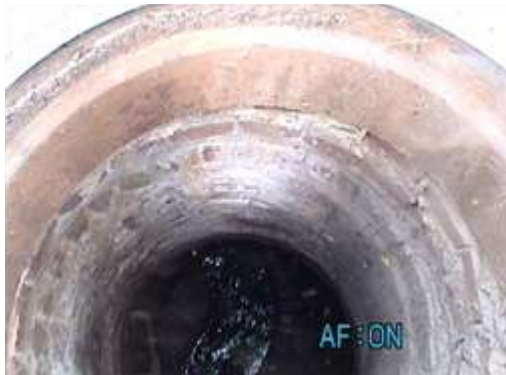
Defect 1

Infiltration: ☐ None ☐ Joint ☐ Cracks ☐ Mortar ☐ Roots ☒ **Wall**

Infiltration

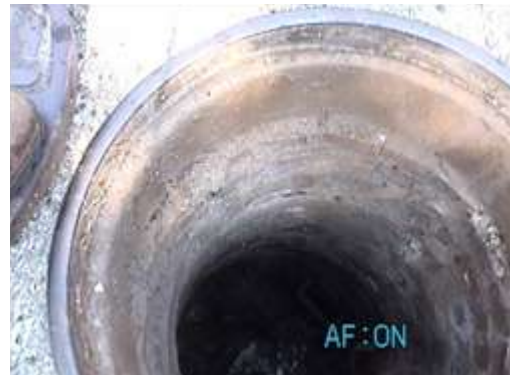
Defect 2

Frame Offset: **1** (in.) Condition: ☐ Sound ☐ Cracked ☒ **Leaks**

Frame leaks

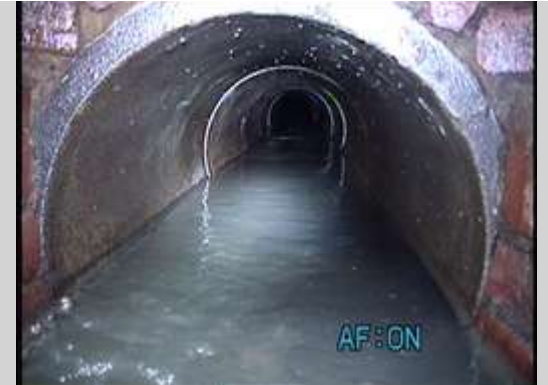
12 O'Clock Outflow

15 in. Circular Gravity Sewer
Pipe Out @ 12 O'Clock

Pipe Height: **15.6** (in.) Rod and Bar (Angled)
Pipe Material: **Clay** ☐ Pipe Lined
Invert Depth: **11.00** (ft.) Flow Characteristics: **Fast**
Deposits: ☒ None ☐ Mud ☐ Sludge ☐ Debris ☐ Grease
Silt Depth: (in.) Deposits Extent:
Infiltration: **None** Pipe Seal Cond: **Sound**

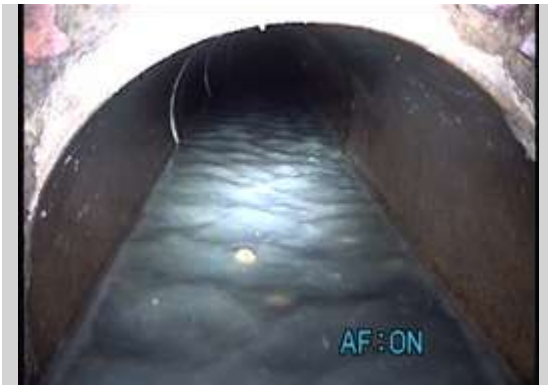
3 O'Clock Inflow

15 in. Circular Gravity Sewer
Pipe In @ 3 O'Clock

Pipe Height: **15.6** (in.) Rod and Bar (Angled)
Pipe Material: **Clay** ☐ Pipe Lined
Invert Depth: **10.80** (ft.) Flow Characteristics: **Slow**
Deposits: ☒ None ☐ Mud ☐ Sludge ☐ Debris ☐ Grease
Silt Depth: (in.) Deposits Extent:
Infiltration: **None** Pipe Seal Cond: **Sound**
